Legislative Chambers Skylight Restoration Feasibility Study

Washington State Legislative Building

Washington State Department of Enterprise Services

April 4, 2017

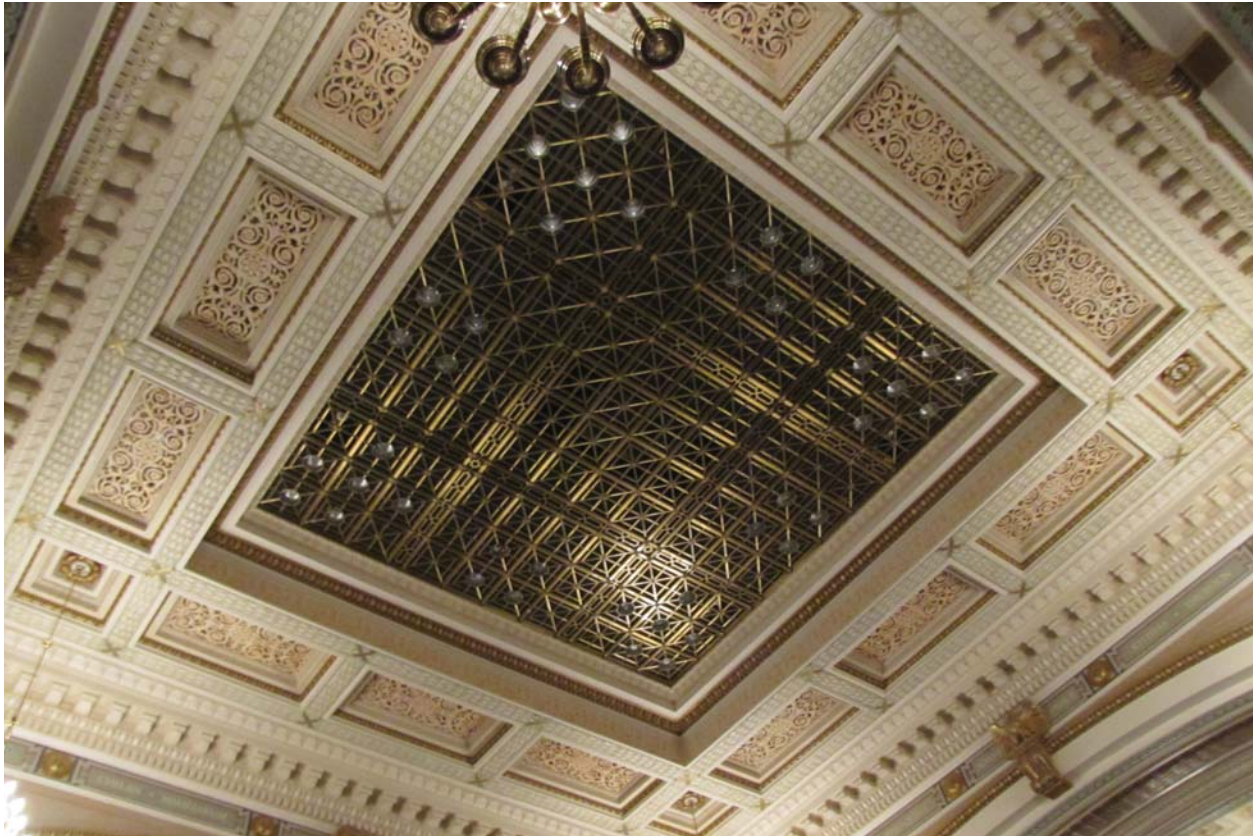
Figure ES03: House bronze ceiling laylight

- 40 light fixtures which have been replaced and upgraded with new lamps to meet changing demands of videography in the Chamber spaces (1930-2003).
- A smoke detector (2003).
- A security camera (2003).
- 2" thick acoustical insulation in lieu of the original opalescent glass panels - partially due to safety concerns of a seismic event as well as for acoustical improvement (1967).

All of these items currently block daylight from entering the Chamber spaces below and would be affected by reconstruction of the skylights. To maximize the amount of daylight and to restore the laylight as closely as possible to the original configuration, the following actions are recommended:

- Restore the 20 laylight bronze panels that once held light fixtures back to the original ornamental pattern.
 - Replace the existing security camera with a smaller security camera, carefully locating it on the fretwork in the least obtrusive location.

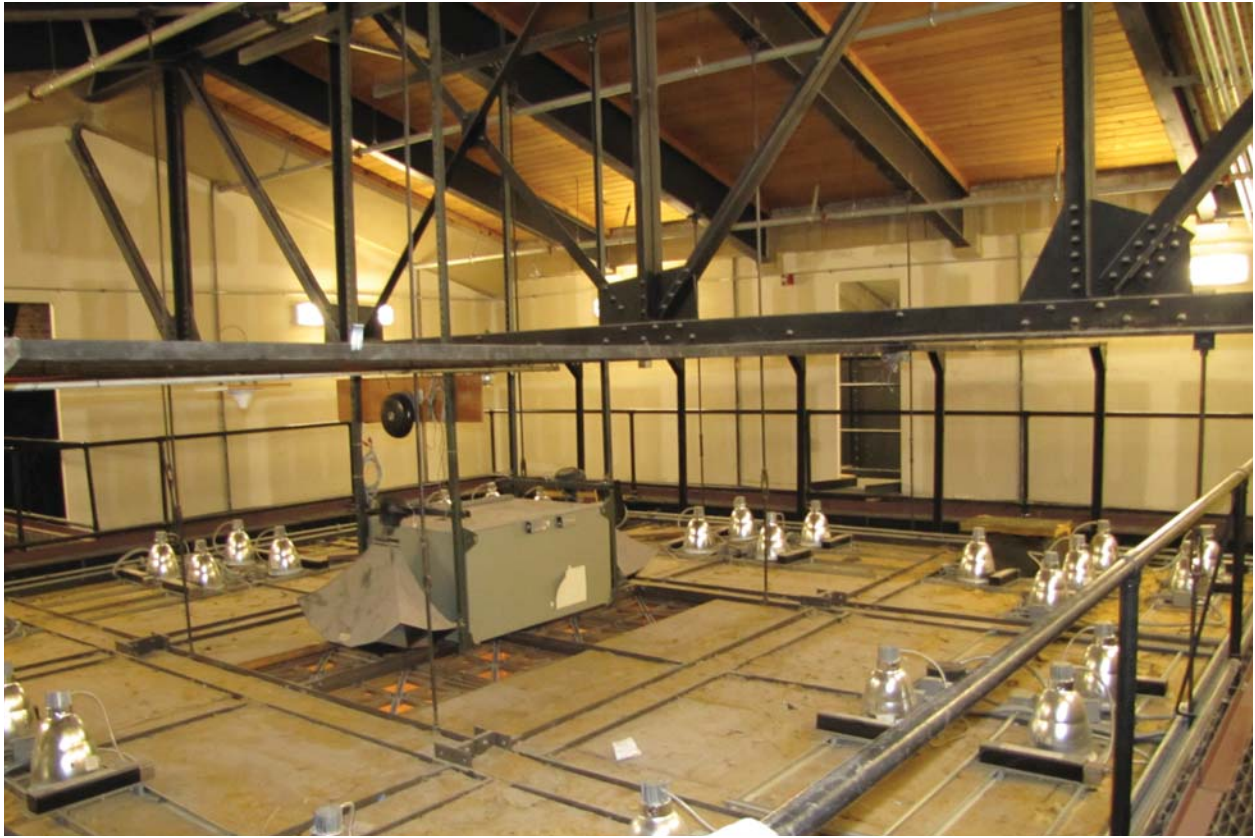
Figure ES05: House skylight attic showing top of bronze ceiling laylight with speaker cluster at the center. A perimeter catwalk provides access.

It is recommended to paint everything (conduit, pipes, structure, walls, railings, etc.) with a highly reflective white paint to create a light box in the skylight attic space. This will allow light from the skylights to bounce from surface to surface minimizing any shadowing from the various objects in the space. To complete the lightbox, doors or sliding panels will need to be added at the existing entry points to other areas of the attic.

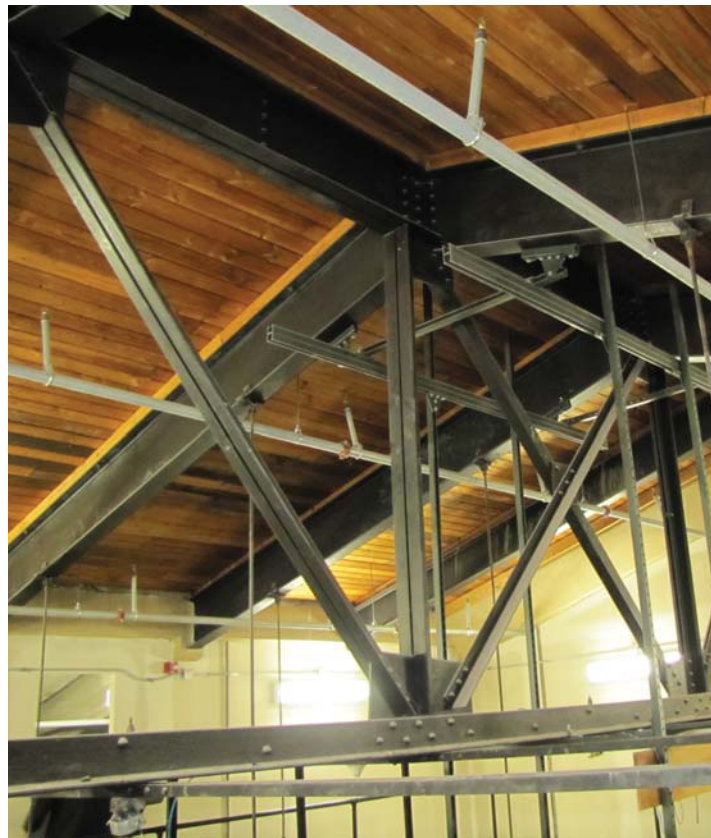
Figure ES07: Wood decking shown replaced the original skylights.

infilled with wood decking as shown in Figure ES07 and the original copper roof was replaced with a terne-coated stainless steel batten seam roof, eliminating any trace of the skylights from the exterior.

The current roof system is still the terne-coated stainless steel roof that was installed in 1975. Terne-coated stainless steel sheet metal is a superior product known for its durability, low maintenance, and high cost. In 2003, the perimeter flashing was replaced and at some point a roof-tie off system was installed, but no other major roof work has occurred.

Considering the high quality and condition of the roof material (which would be very expensive to replace with an equivalent system), it is recommended to modify rather than replace the existing roof system for the new skylights.

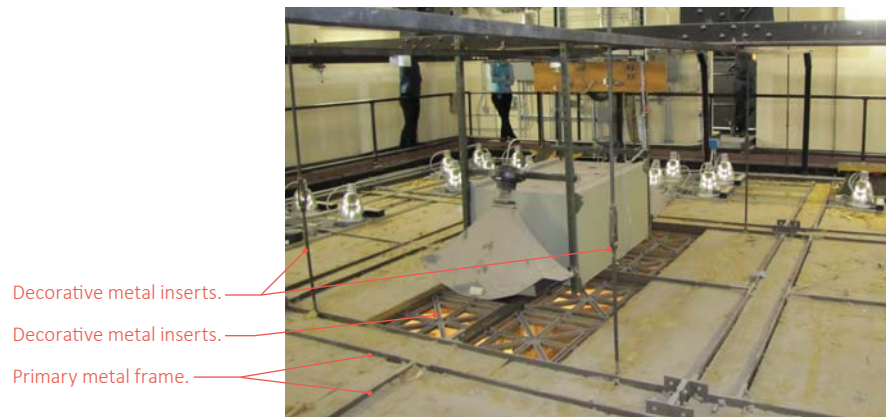
Figure 18: Ceiling laylight from above, showing support hangers

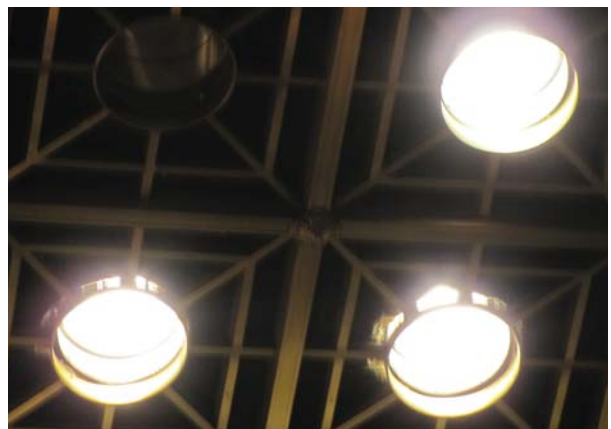
The installed downlights were not designed for the current application and do not fit properly in the openings of the grid. The rings/ downlight reflectors do not line up, creating light leaks around the grid system (see Figure 21). Color shifting, which is when the color of the lamp changes (for instance from more of a warm tone to a greenish or bluish tone) was also present as seen in Figure 19 which is common for metal halide lamps as they age.

Figure 21: Light leaks / misalignment of downlights

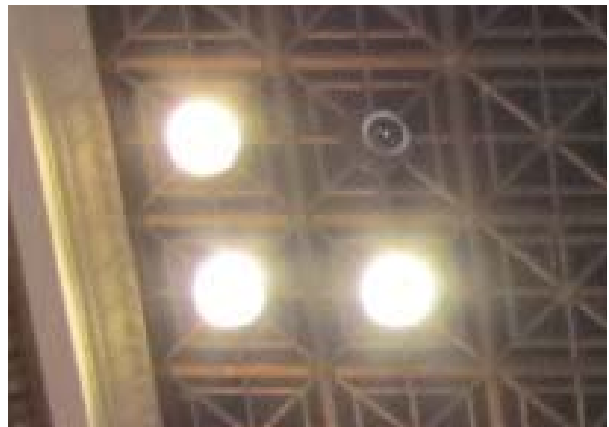
Figure 24: Security camera from Chamber floor

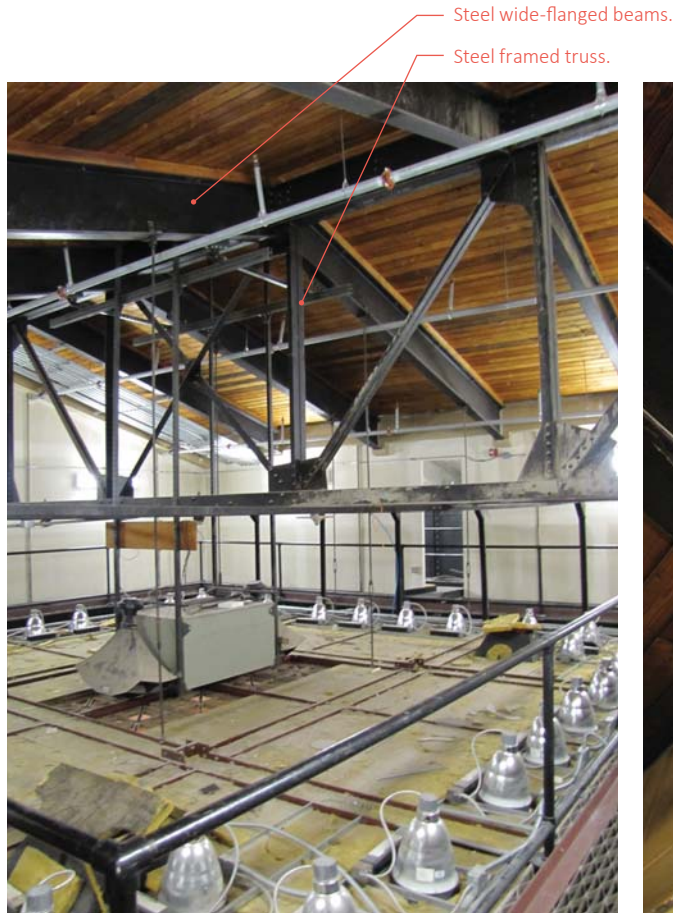
Figure 25: Skylight attic space above the House Chamber (Senate Chamber similar)

The insulation boards on top of the ceiling laylight are clipped into place except where modifications have occurred for new systems. No insulation boards are provided under the large speaker (see Figure 25).

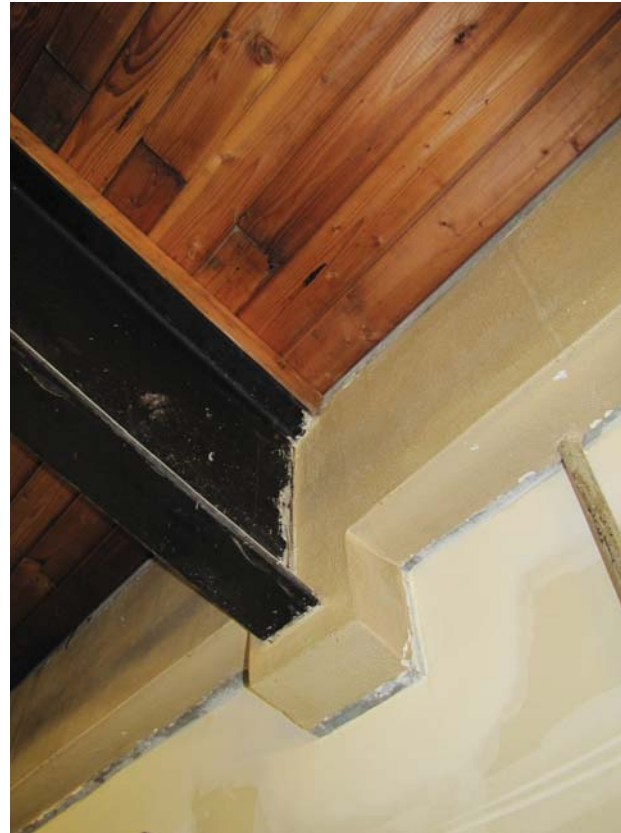
Figure 26: Wood decking above exposed steel beams.

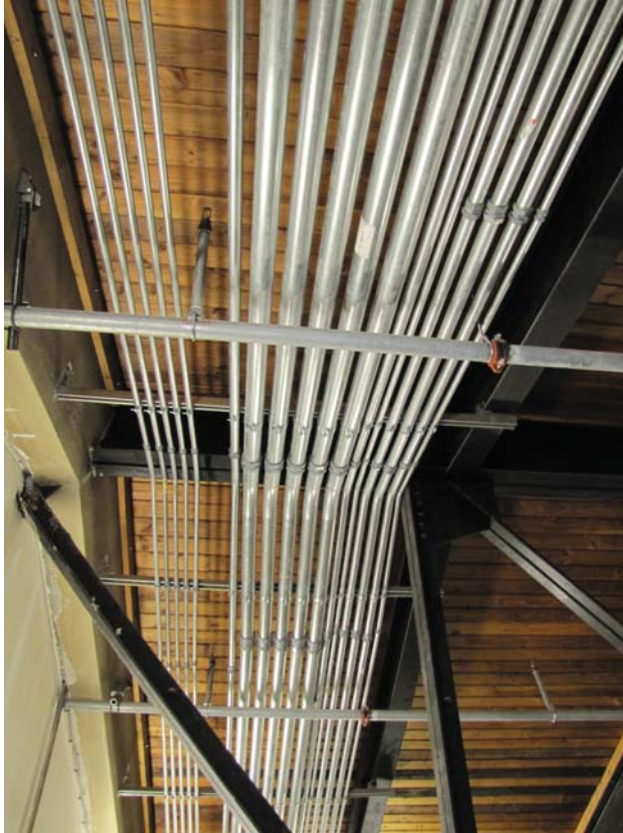
Figure 27: Conduit and piping runs along one of the bays

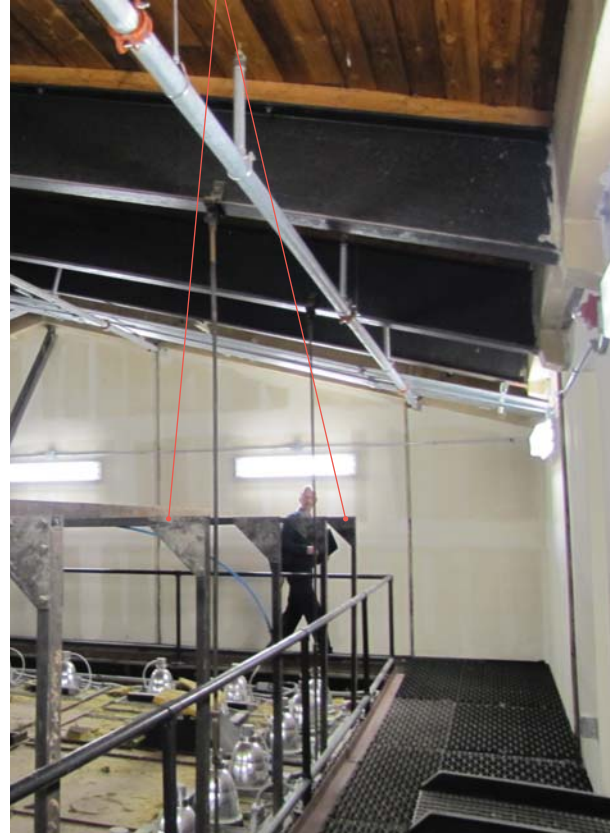
Figure 28: Catwalk and pipe rail around ceiling laylight

The metal framework that was utilized as the support system for the original 20 light fixtures above the ceiling laylight is still present (see Figure 28).

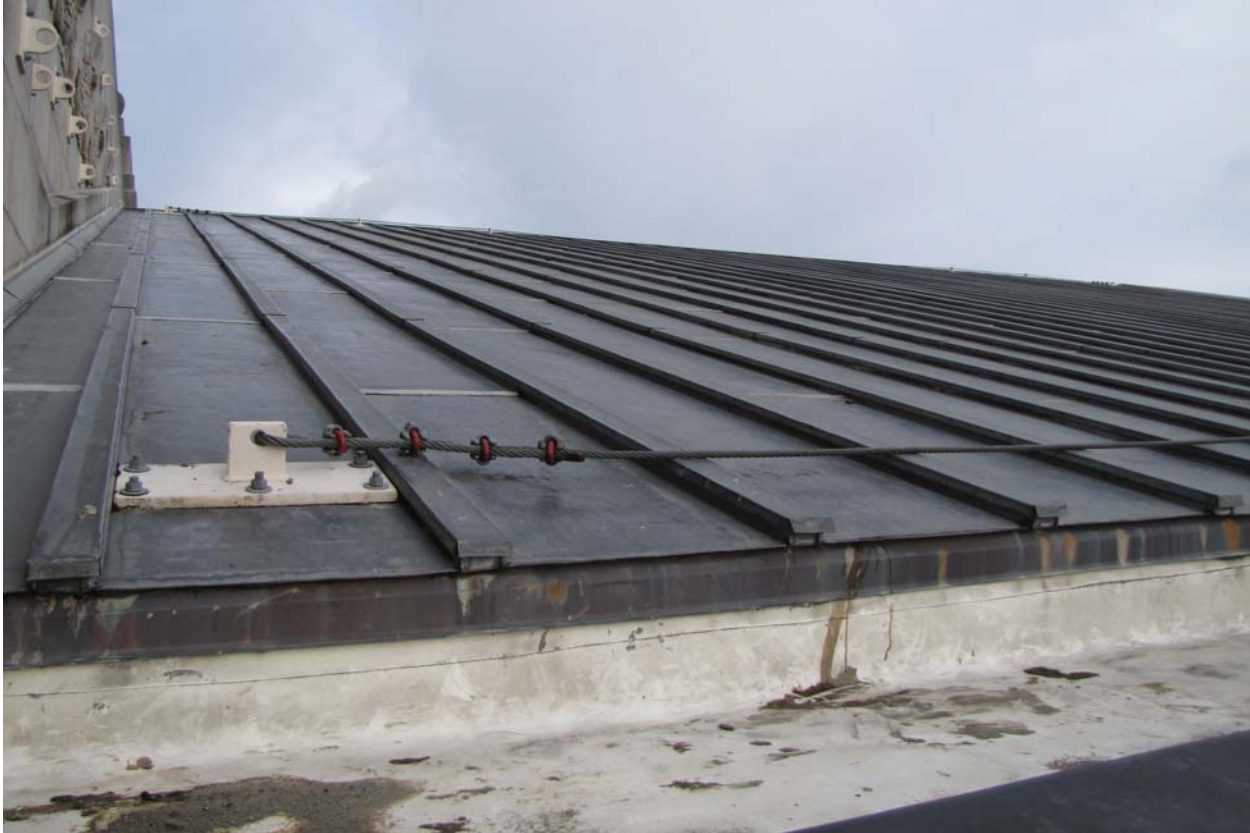
Figure 29: Existing batten seam roof. Corrosion is visible at the perimeter flashing.

ARG was able to view the existing roof from one vantage point which is shown in Figure 29 above. From this view, the roof panels appear to be in excellent condition with no

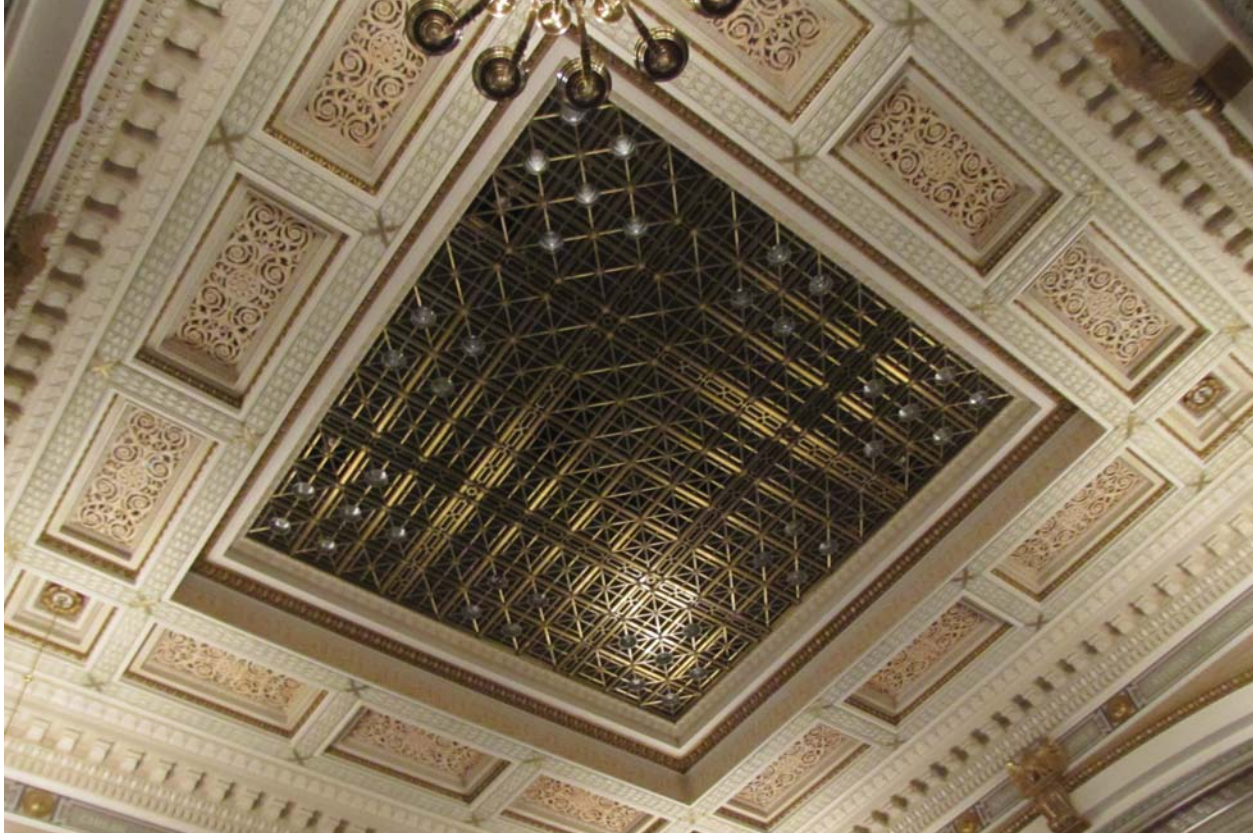
Figure 32: Current ceiling laylight at House Chambers

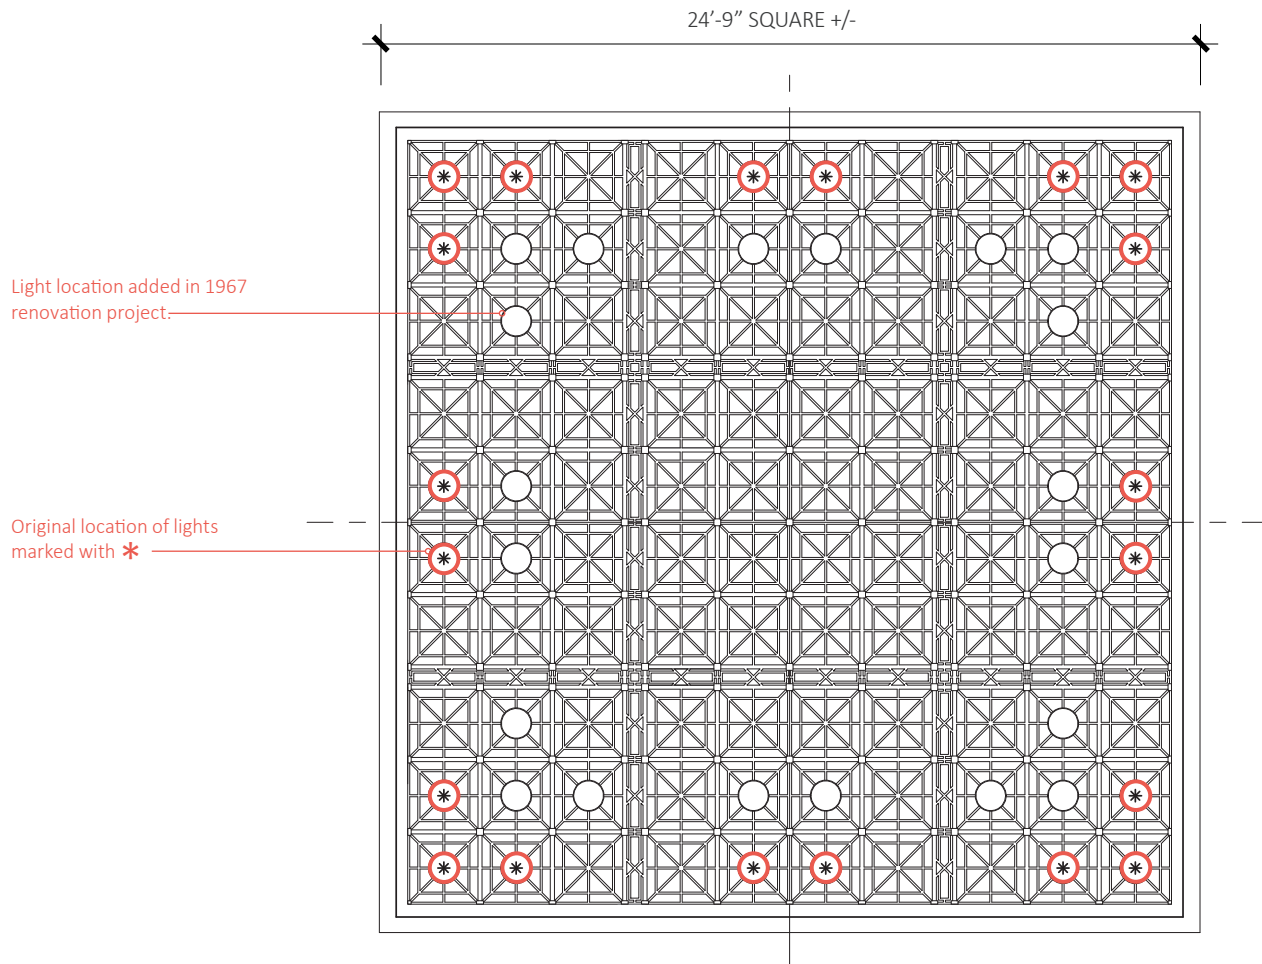
Figure 36: Existing ceiling laylight at House Chamber (Senate Chamber similar)

It would be ideal to restore the ceiling laylight to its original condition which would eliminate all lighting from the metal laylight frame. Unfortunately, due to the current foot-candle requirements, this is not feasible (see Electrical section). Therefore, the lighting needs to be minimized as much as possible. With today's advances in lighting technology, it would be possible to reduce the lighting quantity to the twenty light fixture locations that were added with the first modification of the ceiling laylight as well as provide a smaller diameter fixture to minimize the appearance and still provide adequate lighting. (See Figure 36 and 37).

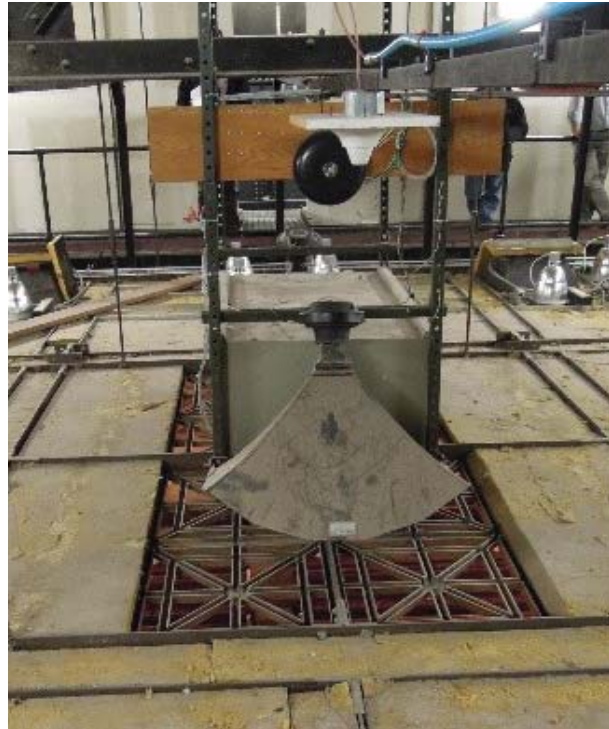
Figure 47: Loud speaker seen from skylight attic space

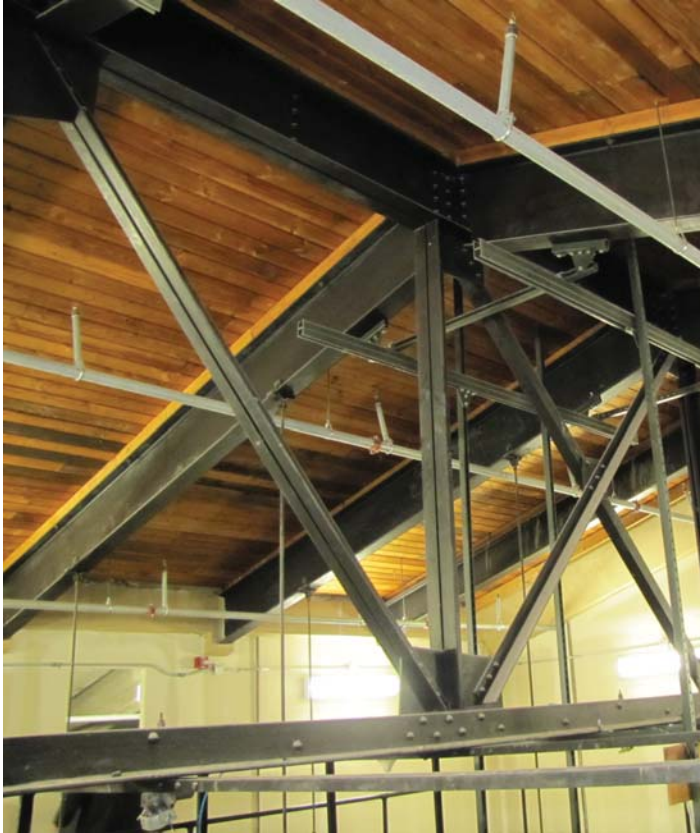
Figure 50: Steel and utilities in Skylight Attic

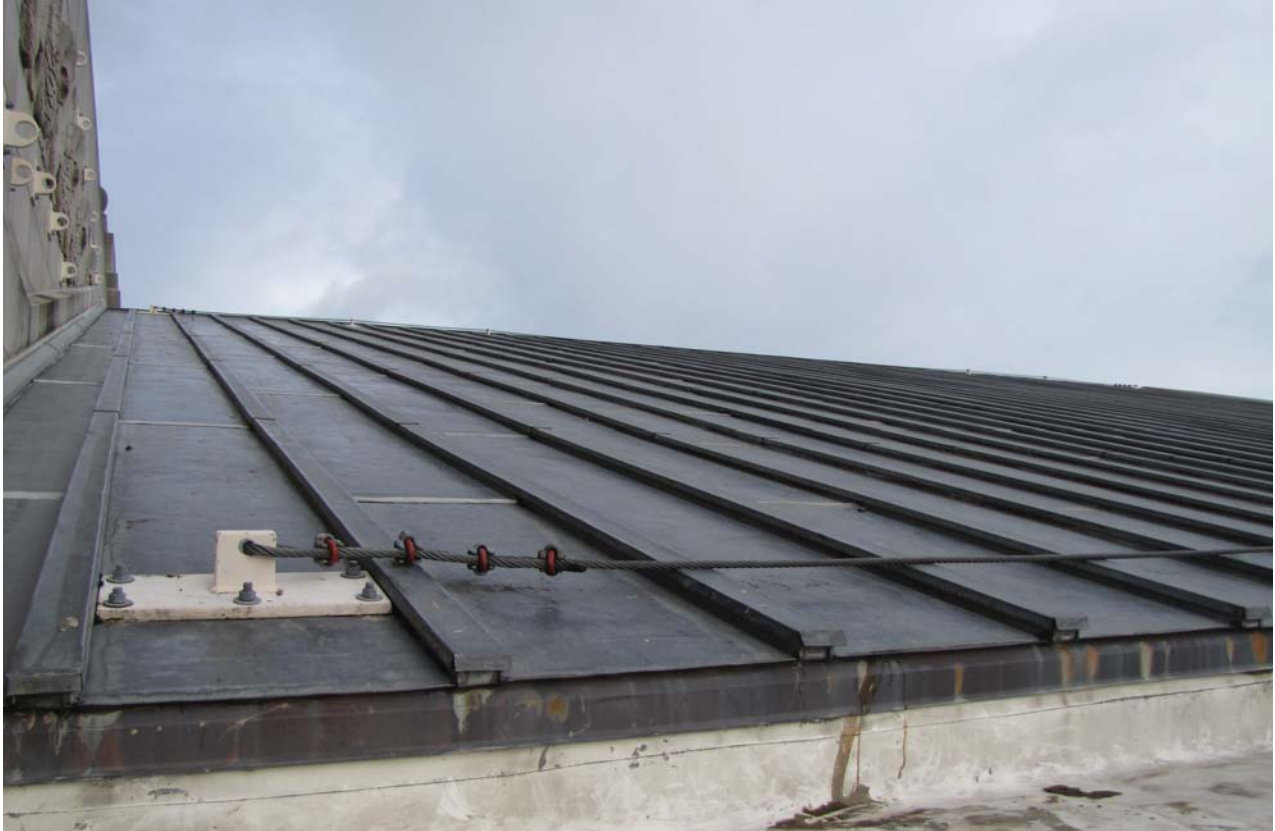
Figure 58: Existing roof at House and Senate Chambers

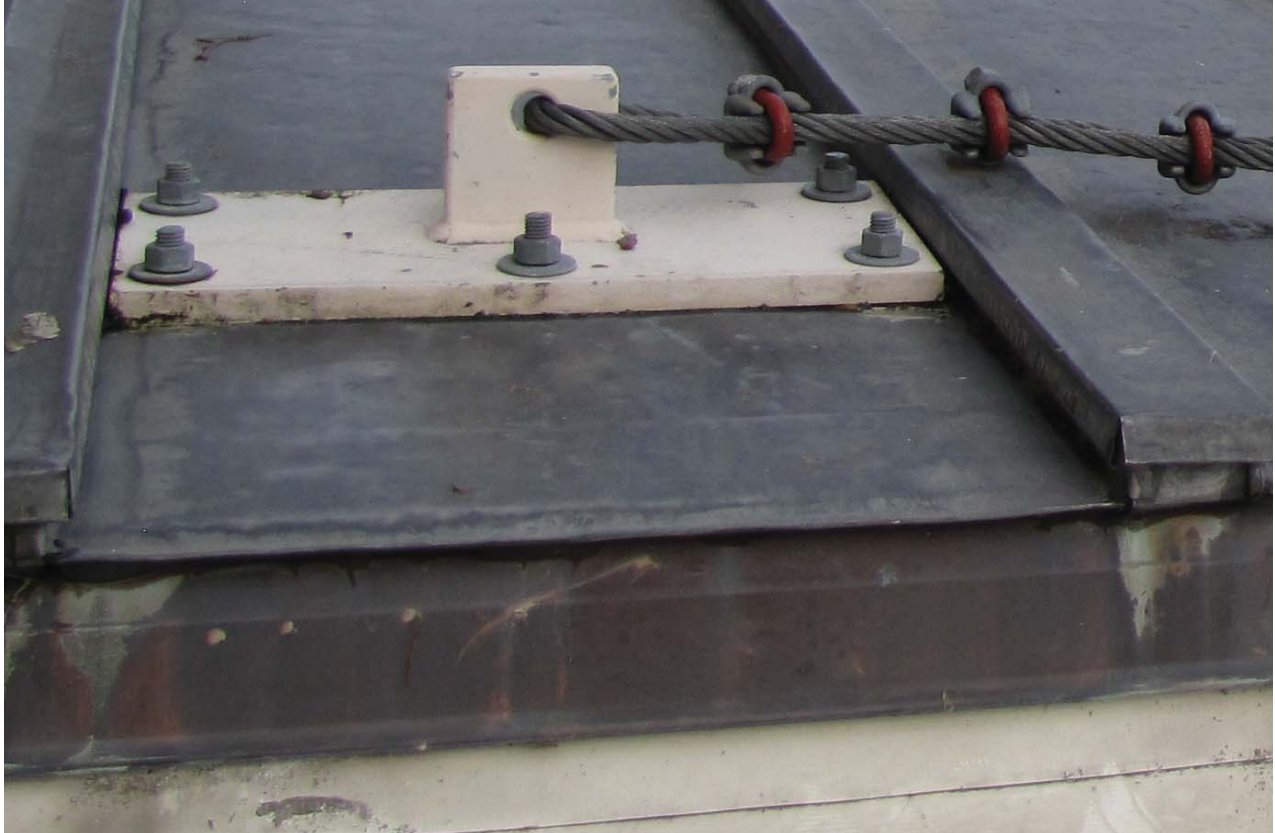
Figure 59: Detail of roof tie-off system and staining of perimeter copper flashing

The roof tie-off system should be replaced with a more appropriate modern system that has mounting brackets that allow for the free-passage of water and a cable line that does not rest on the surface of the roof. The current roof tie-off system is creating a water dam between the battens which may lead to eventual penetration of water at the weak points (the bolt connections). The steel cable resting on the metal roof will continue to abrade the surface, eventually leading to a thinning of the material. This work should be completed whether or not the skylight project moves forward.
