Legislative Chambers Skylight Restoration Feasibility Study

Washington State Legislative Building

Washington State Department of Enterprise Services

April 4, 2017

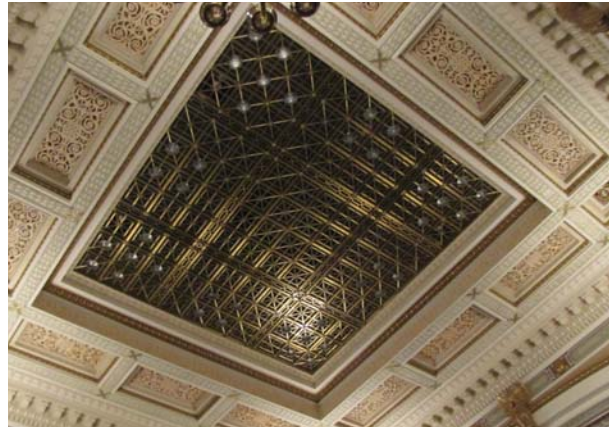
Figure 16: House bronze ceiling laylight

The ceiling laylight was reviewed from below in the chamber space and from above in the skylight attic space. It is evident that the bronze bars have been modified to incorporate larger light fixtures with a thinner metal ring (see Figure 16 & 17). In general, the bronze material appears to be in good condition though a full assessment will be required once the insulation boards are removed.

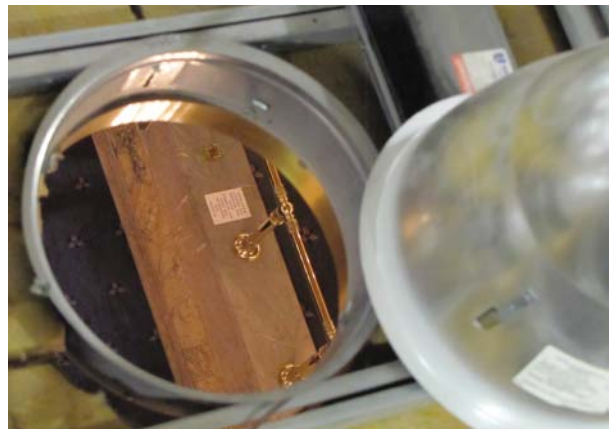
Figure 17: Metal ring added for larger light fixture

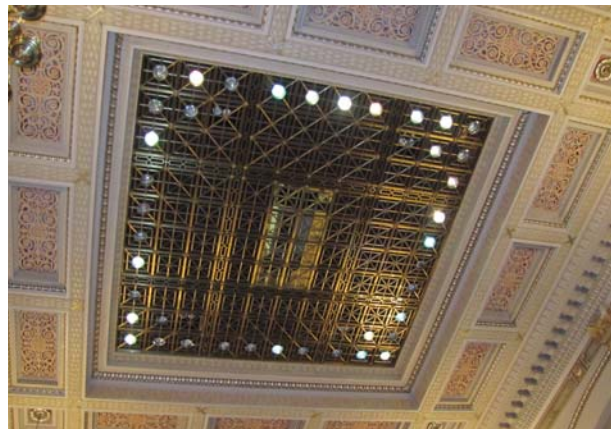
Figure 20: Senate ceiling laylight, showing downlight configuration

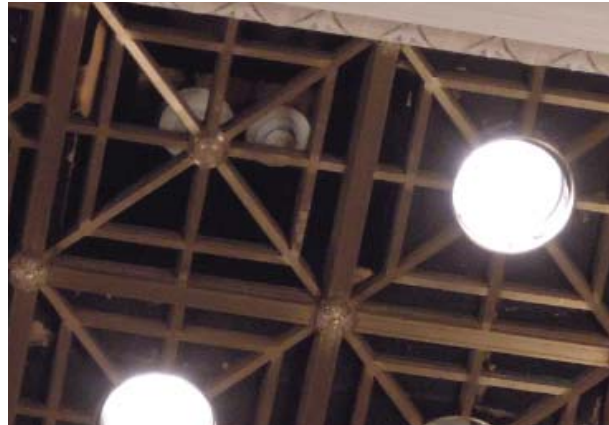
There are currently smoke and heat detectors located above the ceiling laylight for both of the Chambers (see Figure 22 and 23). There are detectors located on each corner of the laylight.

Figure 22: Smoke and heat detectors from Chamber floor

- Replace the smoke detector with a smoke sampling system connected to the existing fire alarm system that will be installed above the laylight. Conduit to run tight to the framework for the laylight to eliminate shadowing. Number of air sampling ports to be determined with the Fire Marshall during design.

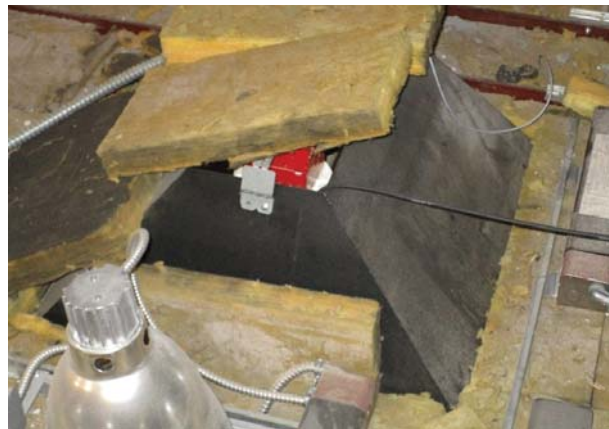
Figure 23: Smoke detector location in skylight attic

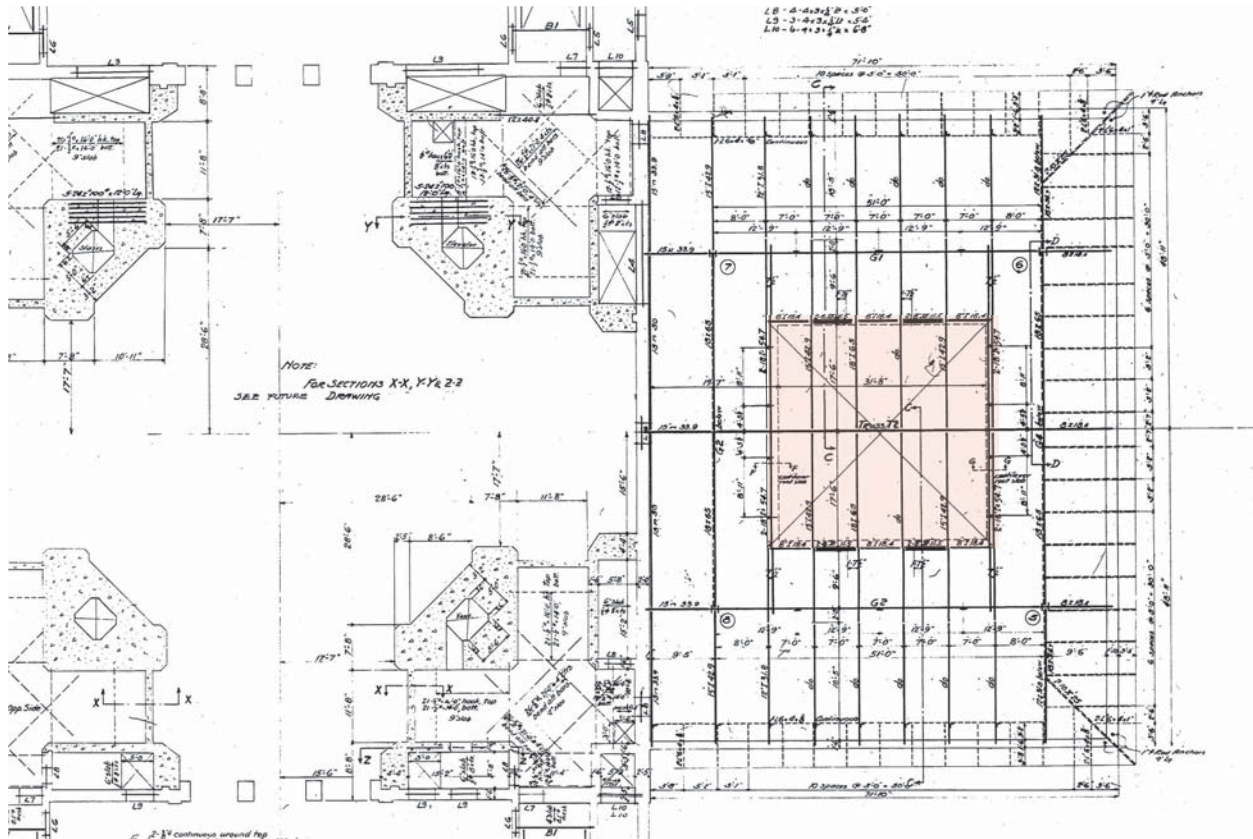
Figure 30: 1923 Construction documents, sixth floor and roof framing plan

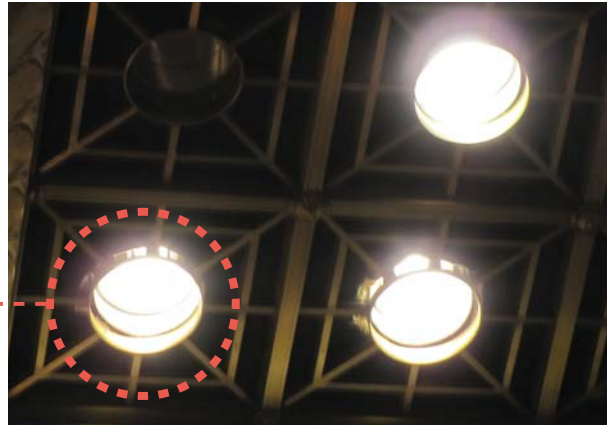
Figures 33, 34, and 35, show how the light fixtures changed over time at the ceiling laylight. The early light fixtures added some time between 1923 and 1967 were a smaller diameter with a concave bronze reflector (see Figure 35). This minimized the visual impact of the light in the bronze ceiling laylight while also creating a more elegant design with the soft curve of the bronze reflector. The added lights in 1967 maintained the same proportions, but eliminated the concave reflector. In the 2003 rehabilitation project, the lights were modified again to fill the full diameter of the ring, becoming the main focal point of the ceiling laylight design.

Large diameter metal halides are full diameter of metal ring.

Figure 33: Current lights

CEILING LAYLIGHT		
<i>Architectural Scope</i>	<i>Quantities/ Percentage</i>	<i>Report Reference</i>
Remove bronze metal ring housings at existing light fixture locations.	40 12" dia. Rings	Fig 33, 37
Repair and restore bronze ceiling grille at 20 locations to return to original "star" pattern design. Metal stock to match materiality and profile of existing grille. Braze to match existing joints.	4 LF of metal "V" extrusions, approximately 2" deep at 20 locations. Note: Original specs state material is bronze.	Fig 37
Repair and restore bronze ceiling grille at 20 locations to return to original light fixture design. Metal stock to match materiality of existing grille with new concave reflector extrusion. Full welds to match existing (assume finish level #2 per the National Ornamental & Miscellaneous Metals Association (NOMMA).	12" diameter extruded concave reflectors at 20 locations. Note: Original specs state material is bronze.	Fig 37, 38

Clean all metal and glass surfaces of ceiling laylight.	Area of ceiling laylight is 612 sf	Fig. 33
<i>Electrical Scope</i>	<i>Quantities/ Percentage</i>	<i>Report Reference</i>
Remove existing metal halide fixtures.	39 locations	
Install New LED downlights/cylinders and branch circuits to existing lighting control panel in attic space.	20 locations	Fig 38
Provide new daylighting controls.	One located in attic space. System Sensor FFAST 8100 series	Fig 45
Remove existing security camera to install new security camera.	BOD HD Mini Dome Network Camera DCS-6004L by D-Link installed on laylight frame	Fig 37 & 48
Provide new speaker system for Chambers.	One location, paint speaker

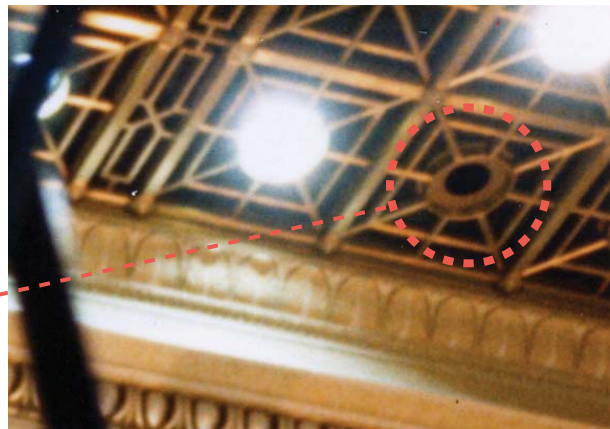
High bay lights added in 1967 show a smaller diameter light with a flat bronze housing.

Figure 34: 1967 Lights

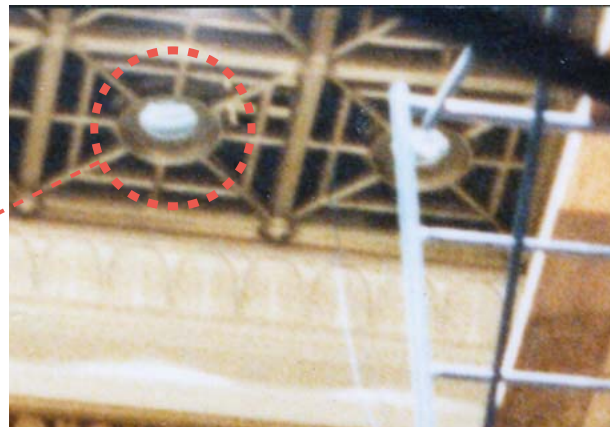
Early incandescent lights show a smaller diameter with a concave bronze reflector.

Figure 35: Early Lights added between 1923 and 1967

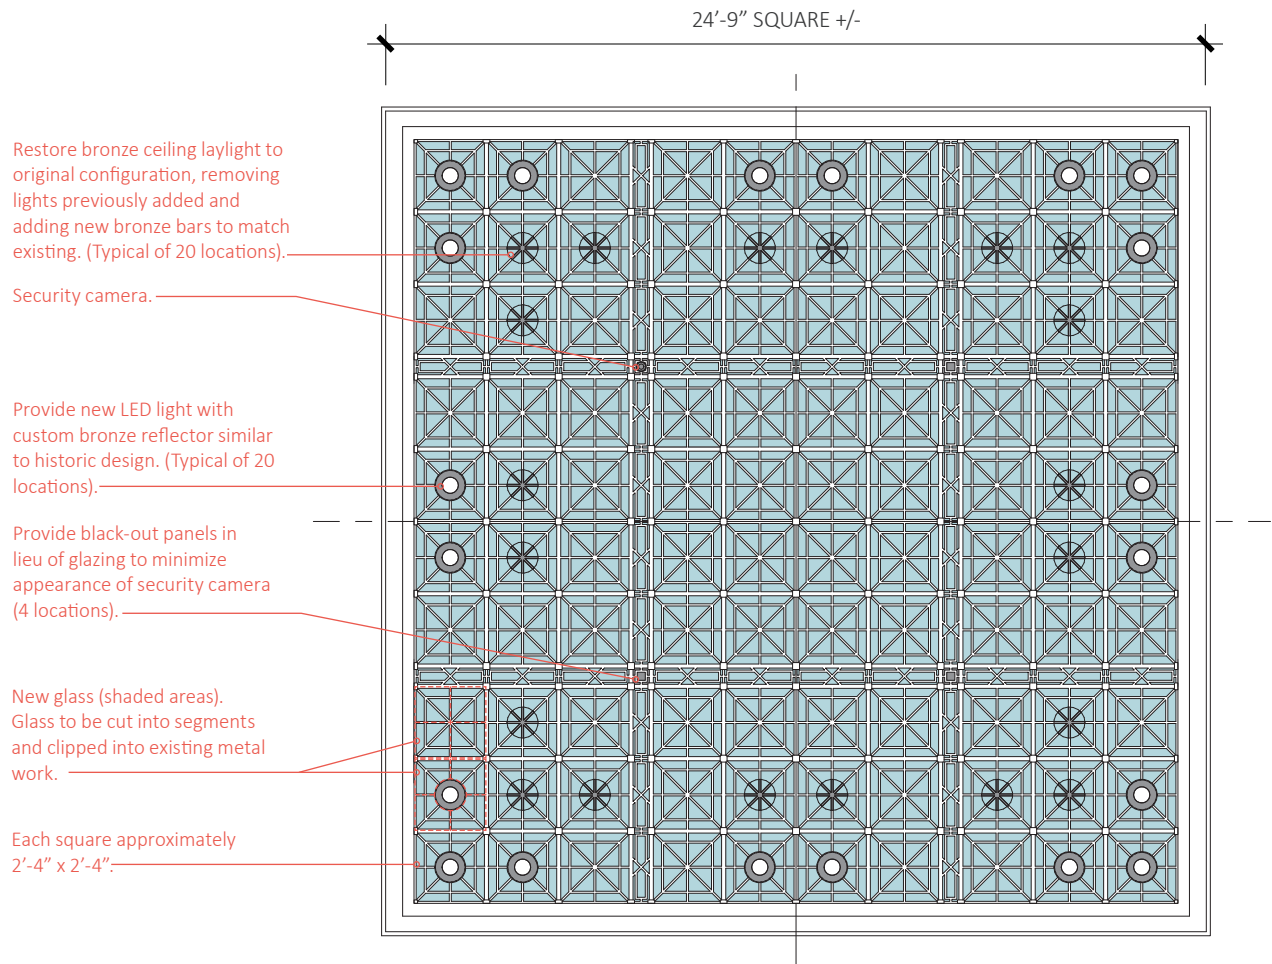
Figure 37: Proposed ceiling laylight restoration for House and Senate Chambers

It would be ideal to restore the ceiling laylight to its original condition which would eliminate all lighting from the metal laylight frame. Unfortunately, due to the current foot-candle requirements, this is not feasible (see Electrical section). Therefore, the lighting needs to be minimized as much as possible. With today's advances in lighting technology, it would be possible to reduce the lighting quantity to the twenty light fixture locations that were added with the first modification of the ceiling laylight as well as provide a smaller diameter fixture to minimize the appearance and still provide adequate lighting. (See Figure 36 and 37).

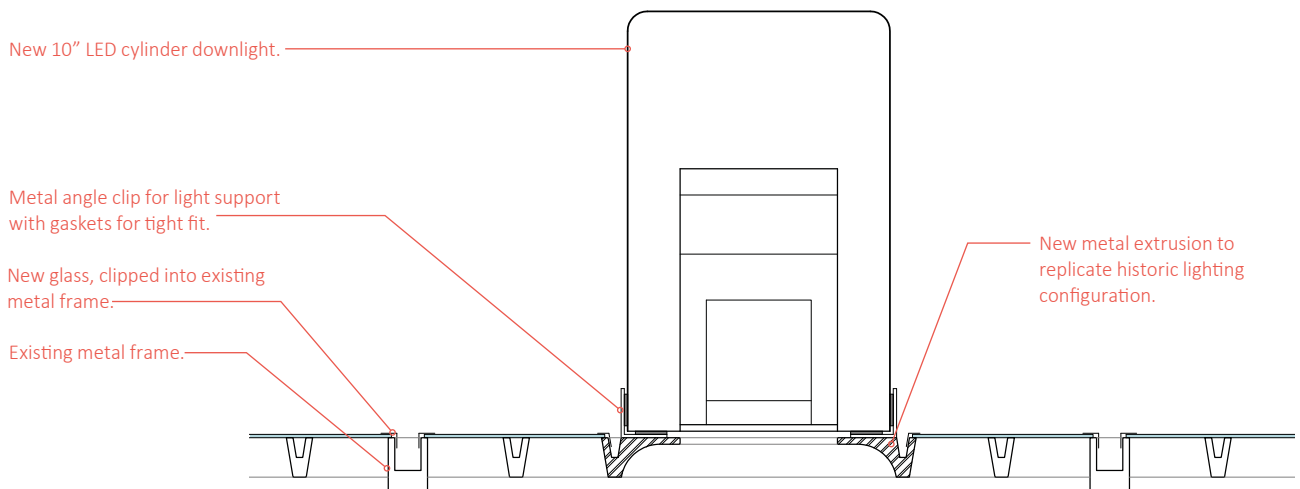
Figure 38: Proposed ceiling laylight restoration for House and Senate Chambers

would be welded to the existing frame (see Figure 38). For the twenty light fixtures that will be completely removed, new molded bronze barstock would be brazed to the existing frame to complete the original "star" design.

Provide angle clips and rubber gaskets at new cylinder downlights for attachment to ceiling laylight.	Four 2"x2" metal angles with rubber gaskets at 20 locations	Fig. 38
LAYLIGHT GLASS OPTION 1 - 1/8" TINTED OPALESCENT Install 1/8" tinted opalescent art glass above ceiling laylight. Glass to be cut into quarter segments and clipped into existing metal work at each grille square. Apply safety film to glass surface. (BOD: Kokomo glass, amber tinted 11 with 3M Impact Attachment System film).	Assume 612 square feet of glass 320 clips at 80 rectangular glass segments 1600 clips at the 400 square glass segments	Fig. 37, 40
LAYLIGHT GLASS OPTION 4 - 1/4" LIGHT-TRANSMITTING RESIN Install 1/4" ecoresin panel above ceiling laylight. Panels to be made of two 1/8" panels with high-res image interlayer, cut into full square segments and clipped into existing metal work at each grille square. (BOD: 3-Form ecoresin with custom image).	Assume 612 square feet of glass 160 clips at 40 rectangular glass segments 336 clips at the 84 square glass segments	Fig. 37, 40

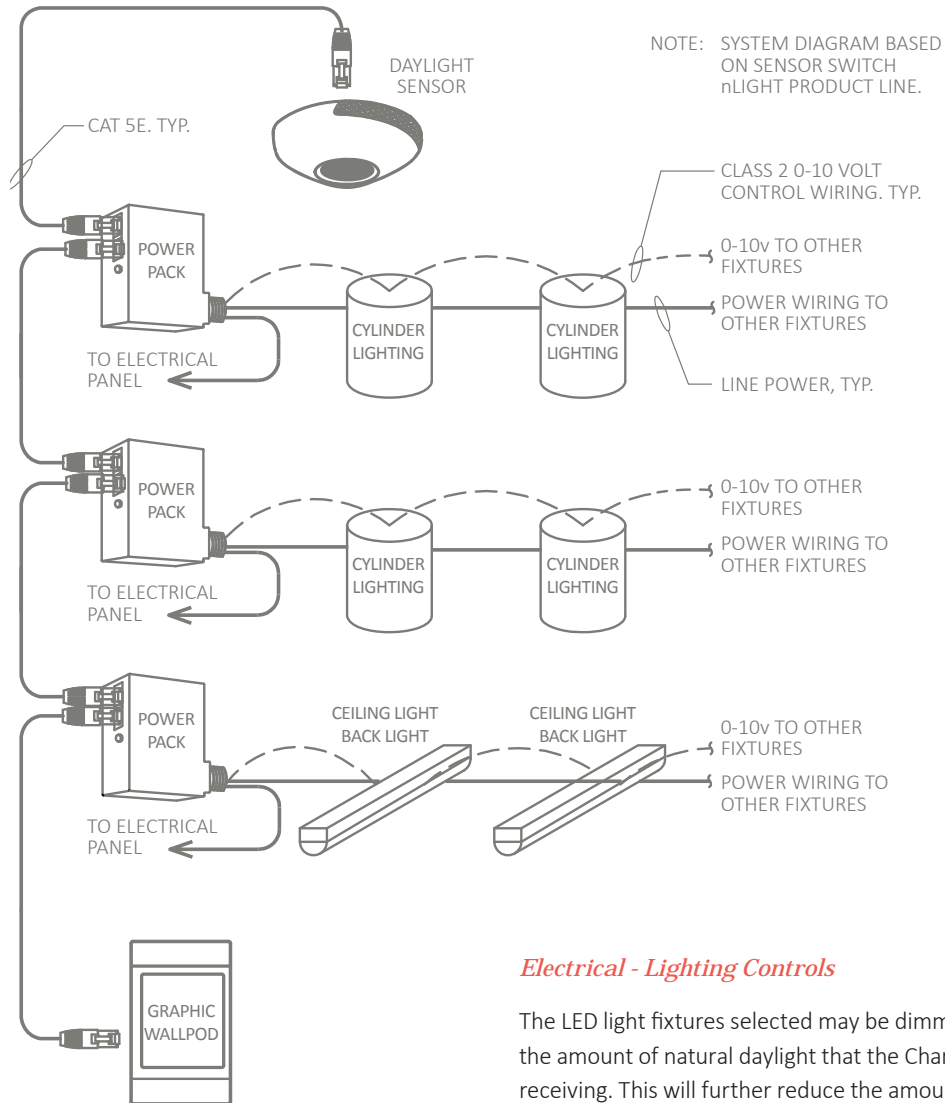
Figure 45: Daylighting controls

A daylight sensor can be located in the attic space between the ceiling laylight and the new skylight to control the ceiling laylight fixtures, thus preserving the historic appearance in the Chambers. The existing on/off toggle switch can be replaced with a dimmer switch to be able to manually dim the lights from the Chamber floor. (See Figure 45).

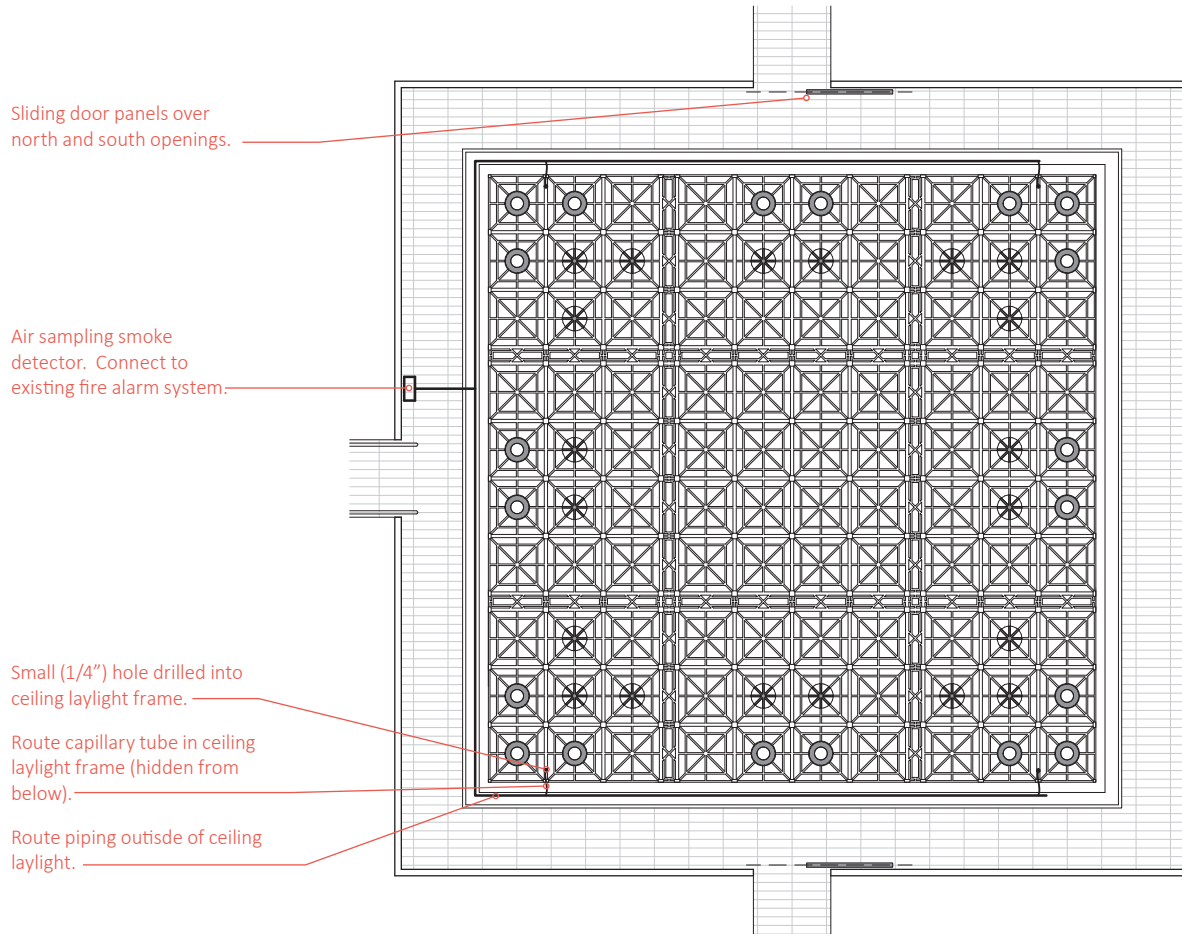
Figure 46: Smoke detection system locations at Senate, House similar

SKYLIGHT ATTIC		
<i>Architectural Scope</i>	<i>Quantities/ Percentage</i>	<i>Report Reference</i>
Paint all walls with a 90% reflective white paint.	1540 sf	Fig 49, 50, 51
Paint all exposed utilities and steel at roof level and piperail at catwalk with a 90% reflective white paint along with catwalk pipe rail. Protect ceiling laylight and catwalk during painting.	Room area is 1156 sf... Not sure best way to quantify this.	Fig. 40, 41, & 42
Provide painted sliding panel at existing openings into skylight attic.	Two 7'-0" x 3'4" sliding panels with top track	Fig 42
Electrical Scope		
<i>Electrical Scope</i>	<i>Quantities/ Percentage</i>	<i>Report Reference</i>
Install new LED ceiling light fixtures for illumination of ceiling laylight.	20 locations, similar to HE William LLMS series 4' fixture with 2600 lumen output & 5000K CCT	
Install smoke detection system.	Four 1/4" diameter holes in laylight frame, new panel to be provided in attic space	Fig 46

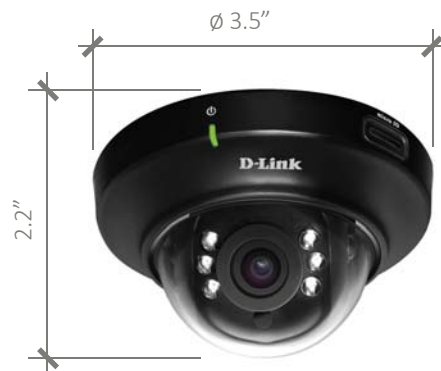
Figure 48: Mini-dome security camera

The security camera needs to be re-located to be as unobtrusive as possible. The ceiling laylight is still the best location since it does not disturb the adjacent historic plaster ceiling. It is recommended to utilize a smaller “mini dome” security camera as shown in Figure 48 and place it at the laylight grid intersection as shown in Figure 37 in lieu of glass. The remaining three square intersections will have black-out panels in lieu of glass to keep the design symmetrical and not attract attention to the camera. This approach requires no modifications to the laylight frame which is preferred.

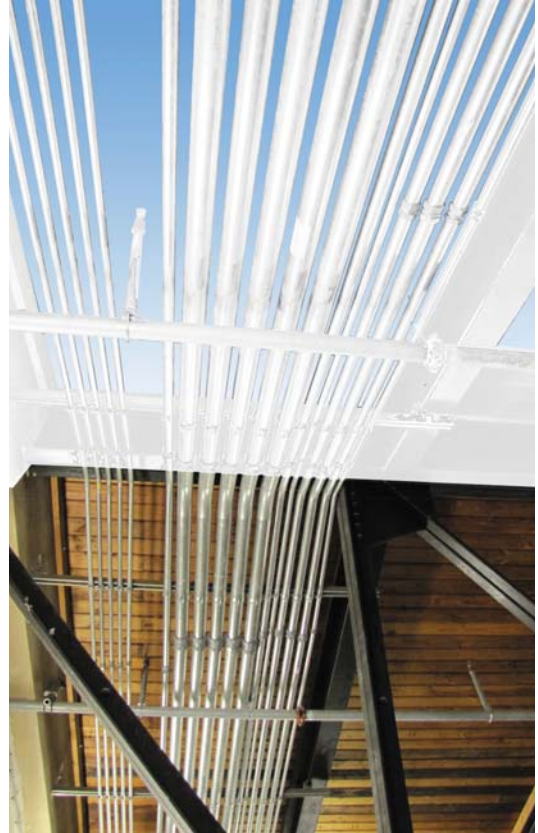
Figure 51: White paint at utilities and steel

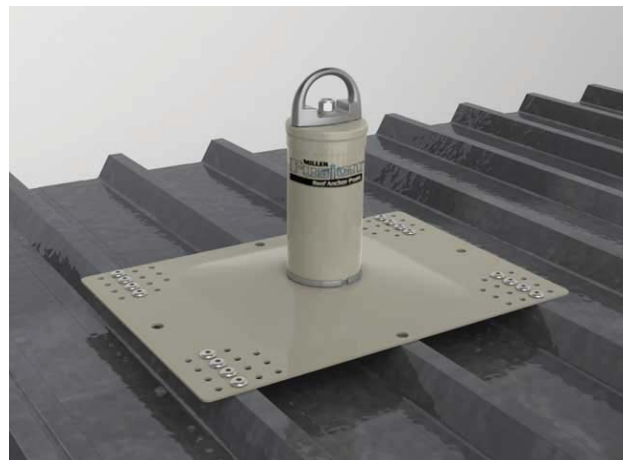
Figure 60: Raised roof tie-off connection (recommended)

The roof tie-off system should be replaced with a more appropriate modern system that has mounting brackets that allow for the free-passage of water and a cable line that does not rest on the surface of the roof. The current roof tie-off system is creating a water dam between the battens which may lead to eventual penetration of water at the weak points (the bolt connections). The steel cable resting on the metal roof will continue to abrade the surface, eventually leading to a thinning of the material. This work should be completed whether or not the skylight project moves forward.

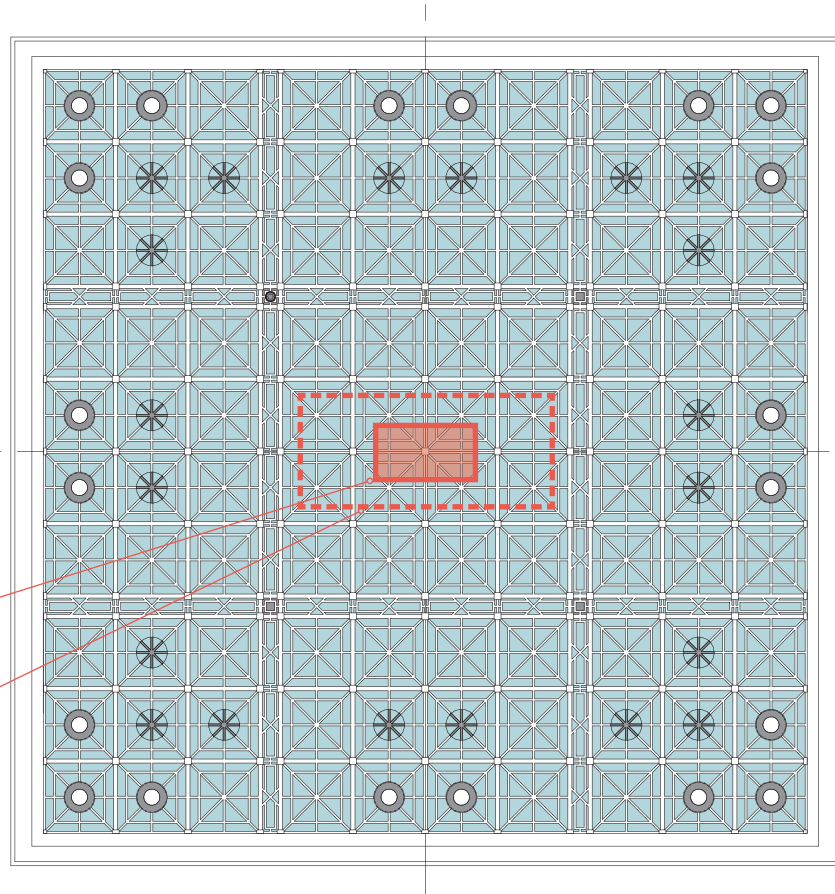
Figure 63: Existing speaker cluster compared to new speaker cluster

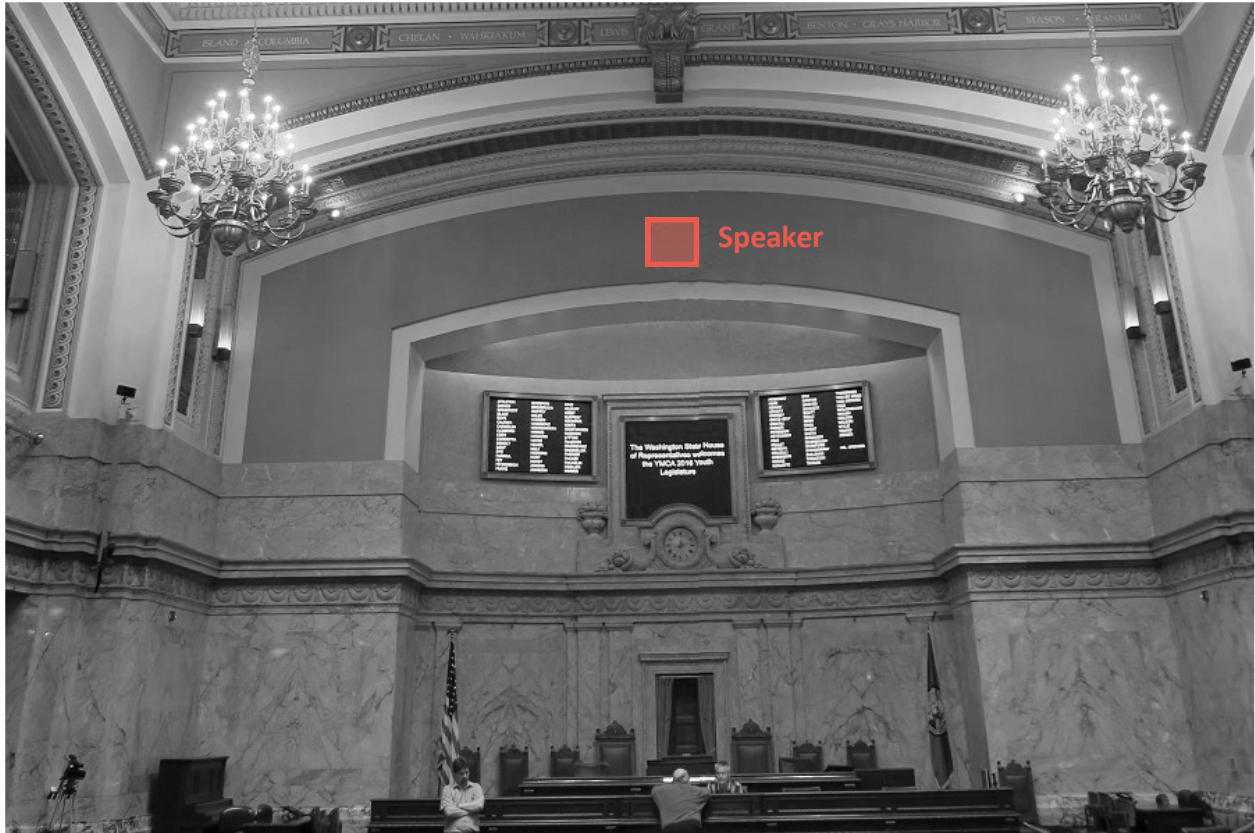
Figure 65: Alternate speaker location

This option proposes removing the speaker system from the skylight entirely. One possible location would be on the wall as shown in figure 65. The speaker system could be painted to help blend in, but it would be plainly visible.
